Hydro One Case Study

- Kleenoil units were first installed at Hydro One in 2004.
- The fact that the Kleenoil filter cartridge removes 99.95% of all water made it very appealing to Hydro One.
- After verifying that the Kleenoil filter removed water it was decided that the filter should be installed on all the trucks for safety purposes.
- These trucks have dielectric tests done on a semi-annual basis. If there is water in the oil they have the potential to transfer electricity from the power lines to the truck in the event of a blown hose. Should the truck fail this test it is taken out of service and the oil is changed and system is flushed. This is very time consuming and expensive.

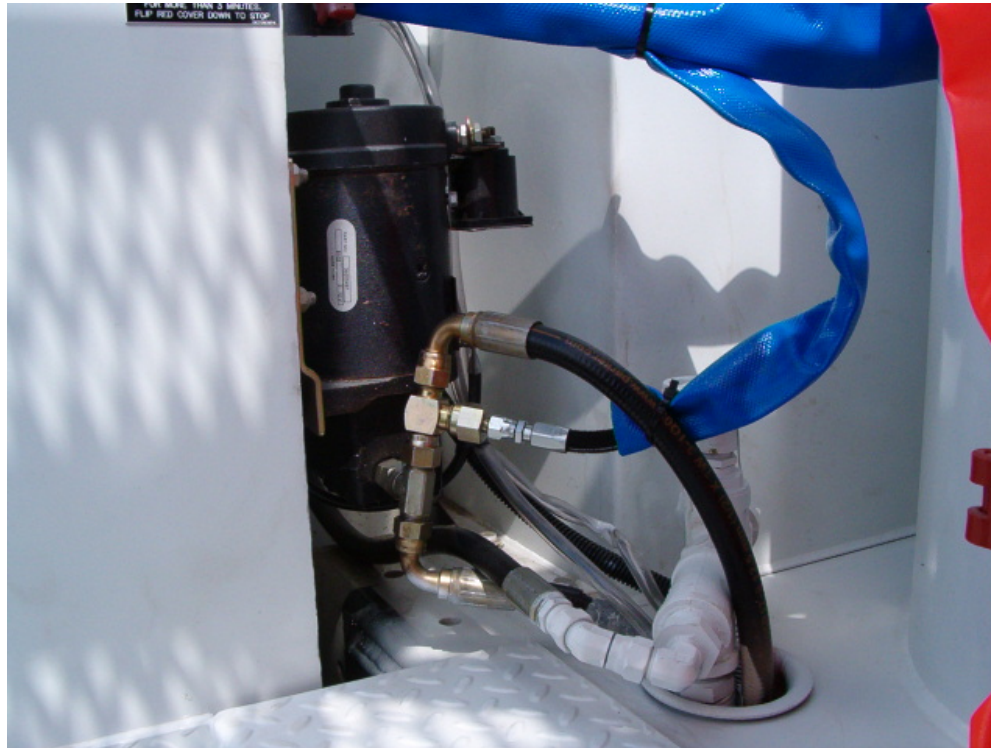
- Oil inlet on an early Altec installation.

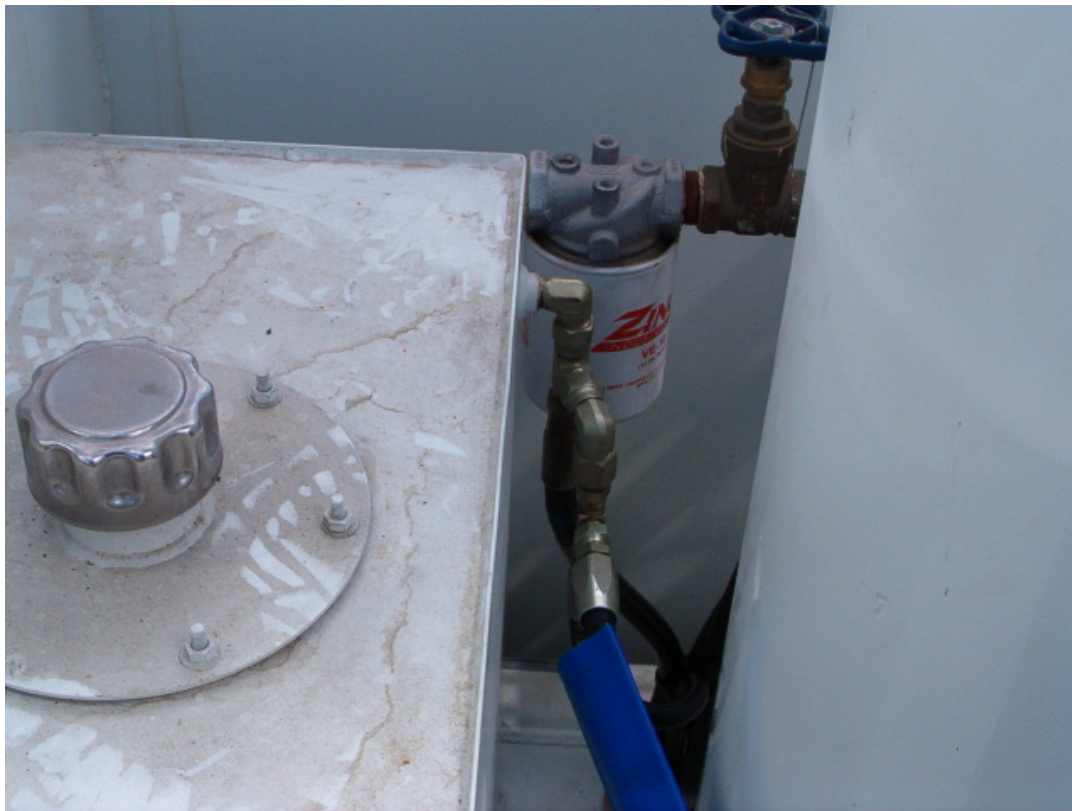
- Return point on all installations

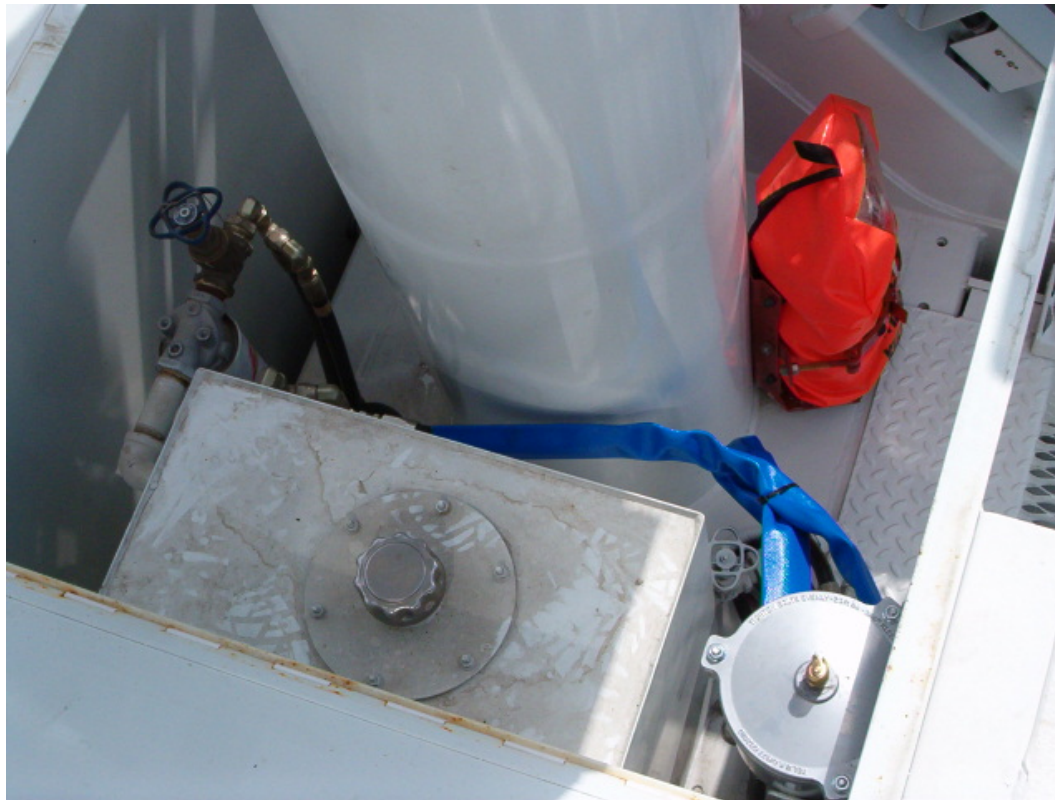
- Filter installed with both the inlet and return lines

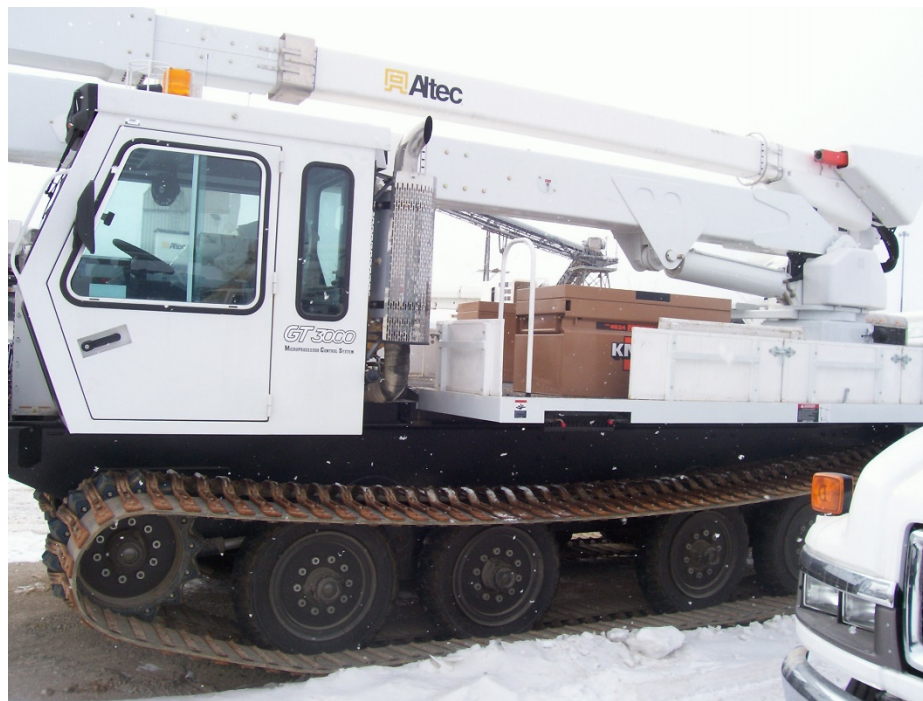
- Altec GT3000 track machine that has both the hydraulics and hydrostatic's done

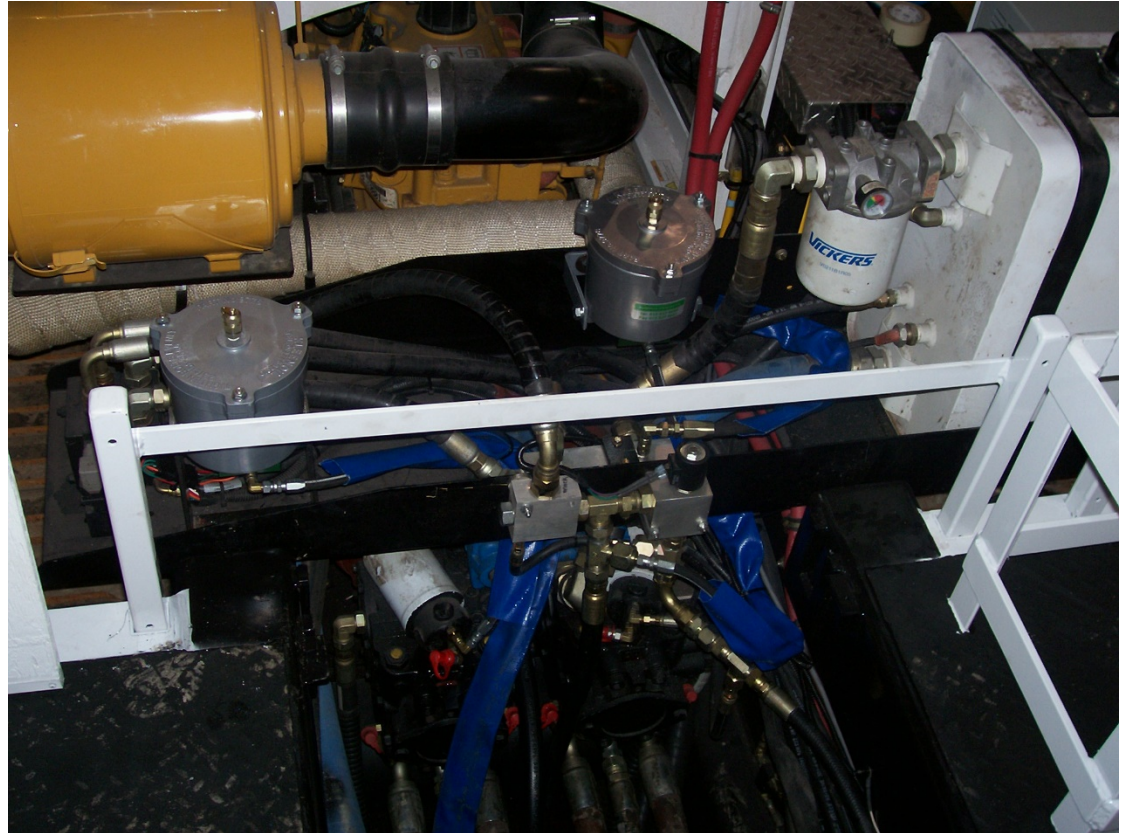
- This photo shows the installation. On these machines the hydraulic pick up is right at the pump and the return is to the top of the tank. The hydrostatics is picked up via charge pressure and returned back to top of tank.
